Manhole Inspection Summary

Manhole # S33EE1016MH

Insp Date: **3/6/07 2:14 PM**

Location Address: **3805 39TH ST**

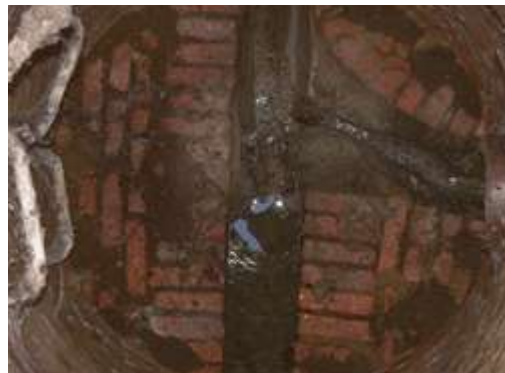
Top View

Bench and Channel debris.

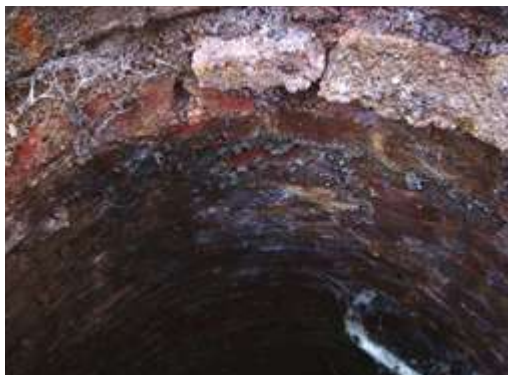
Defect

Frame leaks. Adjustment deterioration, loose brick and infiltration.

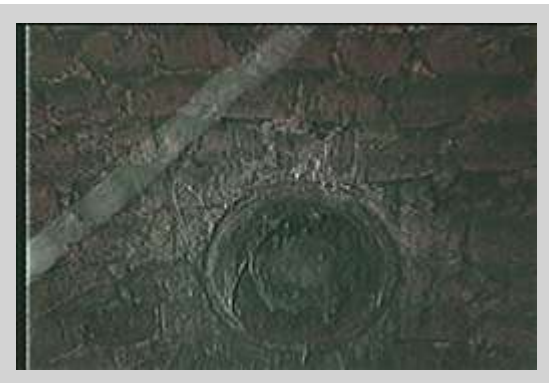
8 in. Circular Gravity Sewer Pipe In @ 3 O'Clock

Barrel deterioration and infiltration.

Deposits: ☐ None ☒ **Mud** ☐ Sludge ☒ **Debris** ☐ Grease

Silt Depth: **1** (in.) Deposits Extent: **Light**

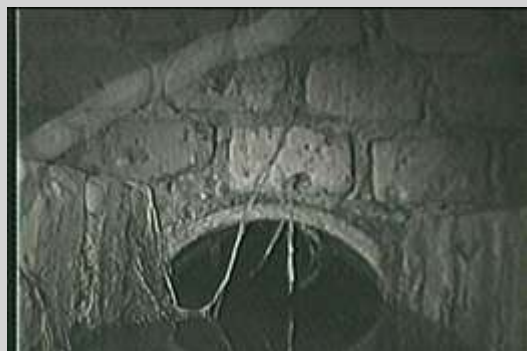
Pipe In @ 6 O'Clock

Barrel root intrusion and infiltration.

Deposits: ☐ None ☒ **Mud** ☐ Sludge ☒ **Debris** ☐ Grease

Silt Depth: **2** (in.)

Pipe Seal Cond: **Roots**
